Fire Risk Assessment

Property assessed: 1-36 Marmion House Dial Lane
West Bromwich B70 0LL

Client: Riverside

FRA Inspection Date: 01/04/2019
FRA Issued to Client: 15/04/2019
FRA valid to: 15/04/2020
FRA completed by: Savills (UK) Ltd,
33 Margaret Street, London W1G 0JD
T: 020 7409 8737
E: fireriskhousing@savills.com

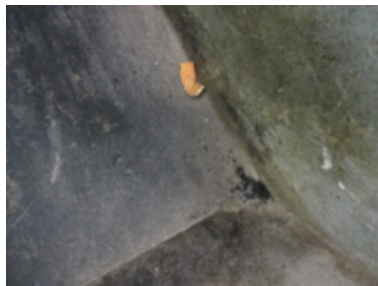
Details		Comments/recommendations	Photo
Question	B.3	Comment: At the time of inspection there was evidence that smoking may take place in the rear stairwell and used cigarette ends disposed of down the refuse chute.

Section	Smoking Policies		
Action ID	199500		
Quantity		Recommendation: Management should ensure that the policy in relation to smoking within the common areas is enforced through communication with residents/ employees or other building users. Residents should also be made aware of the hazards associated with the disposal of cigarette ends in the refuse chute.

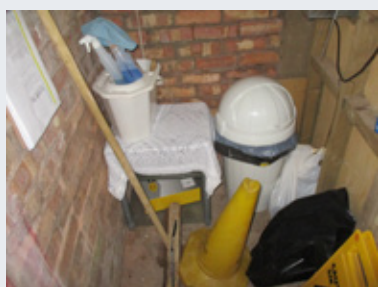
- Known	N/A		
- Potential	N/A		
Priority	Man1	Due Date: 15/05/2019	Status: Not Complete
Question	G.2	Comment: Combustible items were noted in the electric intake cupboard adjacent to Flat 2 on the ground floor.

Section	House-Keeping		
Action ID	199501		
Quantity		Recommendation: All combustible items should be removed from the electrical intake cupboard and the door kept locked.

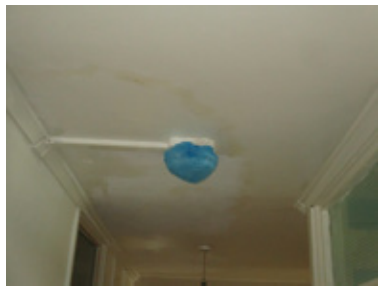
- Known	N/A		
- Potential	N/A		
Priority	Man1	Due Date: 15/05/2019	Status: Not Complete
Question	P.5	Comment: A Grade D smoke alarm was noted within the entrance hallway of sample flats 1, 17, 22 and 29. However, the alarm had been disabled in Flat 17 by covering the detector with a dust shield. No access to other flats.

Section	Means of Giving Warning in Case of Fire		
Action ID	199533		
Quantity		Recommendation: The cover should be removed from the detector in Flat 17 to ensure the system is functioning correctly at all times.

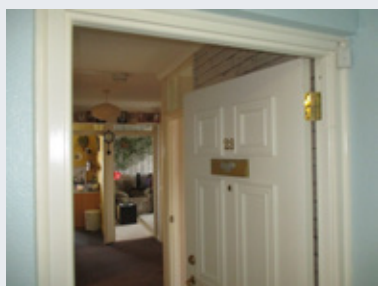
- Known	1		
- Potential	1		
Priority	Man1	Due Date: 15/05/2019	Status: Not Complete
Question	L.6	Comment: Sampled flats 1, 17 and 22 entrance doors were fitted with effective self-closing devices. However the door to Flat 29 has no self closing devices fitted. No access to other flats.

Section	Flat Entrance Doors		
Action ID	199516		
Quantity		Recommendation: An effective self-closing device should be fitted to the doors as noted. Flat 29.

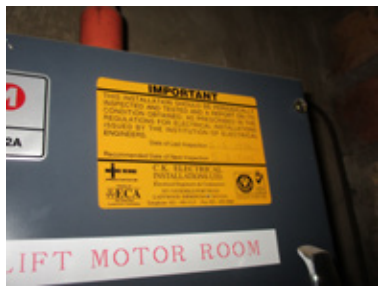
- Known	1		
- Potential	1		
Priority	A	Due Date: 15/07/2019	Status: Not Complete
Question	A.2	Comment: The fixed electrical installation does not appear to have been tested within the last five years as the test sticker is out of date. Date of last test:- 05/03/2001.

Section	Electrical Ignition Sources		
Action ID	199454		
Quantity		Recommendation: Management should confirm/ensure that the common area fixed electrical installation has been inspected and tested within the last five years in accordance with BS 7671:2008 (as amended)

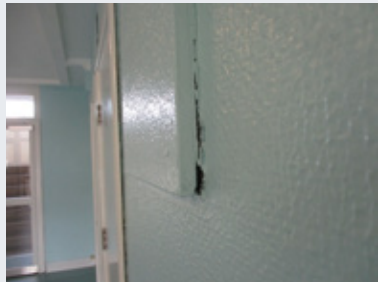
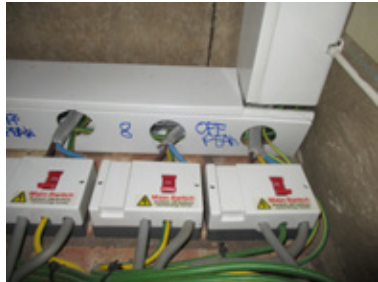
- Known	N/A		
- Potential	32		
Priority	Man2	Due Date: 15/07/2019	Status: Not Complete
Question	Q.2	Comment: It was not possible to sample inspect the hidden voids identified without causing damage or requiring opening up. A number of the covers to the voids did not appear to be adequately sealed, however a contractor on site indicated the voids had been sealed on the inside within the previous 12 months.

Section	Limiting Fire Spread		
Action ID	199535		
Quantity		Recommendation: Management should confirm/ensure that compartmentation within the voids is adequate. This may require an intrusive inspection.

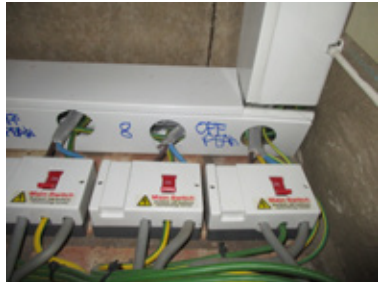
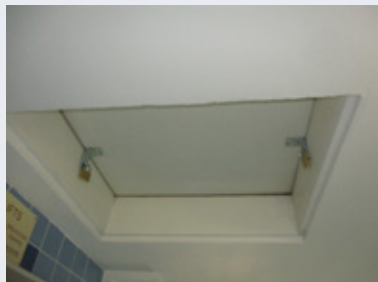
- Known	N/A		
- Potential	5		
Priority	Man2	Due Date: 15/07/2019	Status: Not Complete
Question	Q.4	Comment: It was unclear if the conduit from the electric cupboards/risers have been fitted with sufficient fire stopping to prevent spread of smoke and fire.

Section	Limiting Fire Spread		
Action ID	199537		
Quantity		Recommendation: It should be confirmed that the open conduit passing from the electric cupboards/risers have been fitted with sufficient fire stopping to prevent the spread of smoke and fire.

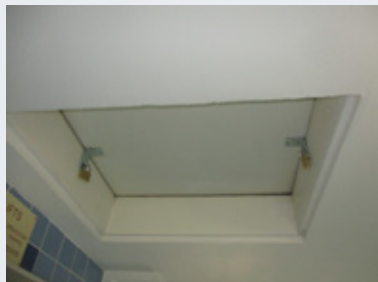
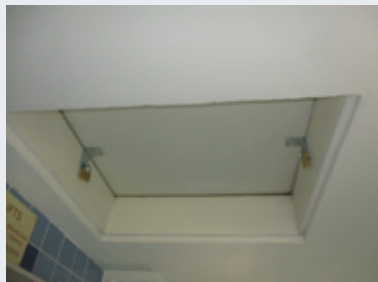
- Known	N/A		
- Potential	8		
Priority	Man2	Due Date: 15/07/2019	Status: Not Complete
Question	Q.15	Comment: There is a ceiling hatch from the seventh floor flat lobby into the lift motor room. It is not clear if the construction of the hatch provides sufficient fire resistance between the lift motor room and the lobby.

Section	Limiting Fire Spread		
Action ID	199540		
Quantity		Recommendation: It should be confirmed that the hatch from the seventh floor lobby to the lift motor room provides a minimum of 60 minutes fire resistance.

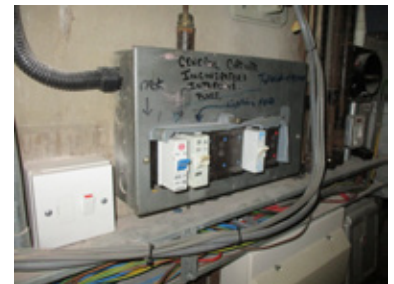
Question - A.3: Is the common area fixed electrical installation free from visible defects? (from cursory visual inspection only)	No
---	----

Comment: The protective cover from the fuse board in the first floor electric cupboard/riser is damaged exposing the fuses.

Recommendation: The defects in the common area electrical installation as noted in the first floor electric cupboard/riser should be repaired			
Priority: B	Known Quantity: 1	Potential Quantity: N/A	Action ID: 199456

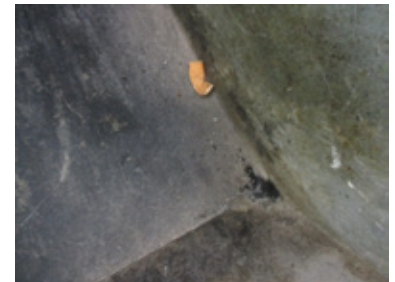
Question - B.3: Does the policy in relation to smoking appear to be observed?	No
---	----

Recommendation: Management should ensure that the policy in relation to smoking within the common areas is enforced through communication with residents/employees or other building users. Residents should also be made aware of the hazards associated with the disposal of cigarette ends in the refuse chute.

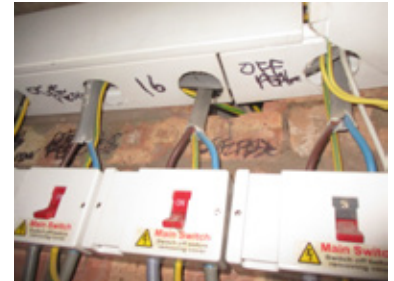
Question - Q.3: Are services risers, shafts, ducts and cupboards in the common area appropriately enclosed with fire resisting construction and adequately fire-stopped?	No
--	----

Recommendation: The hole/s noted should be sealed with a suitable fire-stopping material such as an intumescent paste. Period of fire resistance required is 30 minutes.

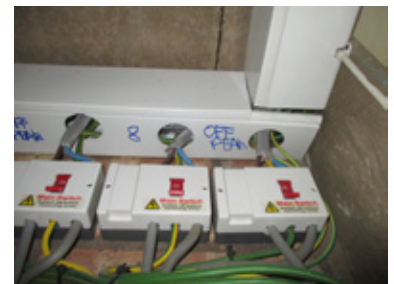
Question - Q.4: Are pipes and other services provided with adequate fire-stopping measures as required where they pass through fire resisting construction? (Consider fire collars etc)	Not Known
---	-----------

Recommendation: It should be confirmed that the open conduit passing from the electric cupboards/risers have been fitted with sufficient fire stopping to prevent the spread of smoke and fire.

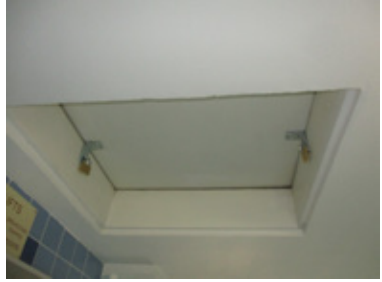
Question - Q.15: Are all other fire spread/compartmentation issues satisfactory? [2]				No
Comment: There is a ceiling hatch from the seventh floor flat lobby into the lift motor room. It is not clear if the construction of the hatch provides sufficient fire resistance between the lift motor room and the lobby.				
Recommendation: It should be confirmed that the hatch from the seventh floor lobby to the lift motor room provides a minimum of 60 minutes fire resistance.
